Component Replacement

- electrical -

Vivaz

U5i, U5a

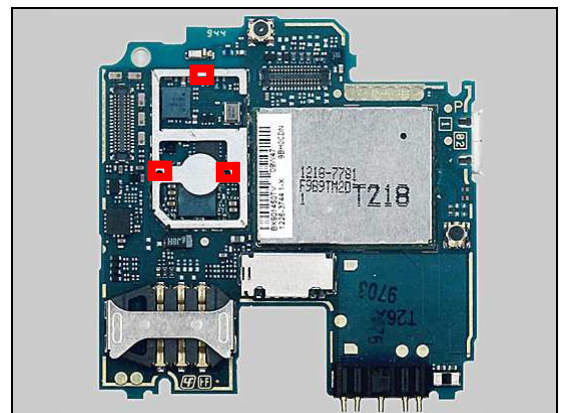
Primary side

- the shield can lid has to be removed
- the red symbols show where the frame should be cut to enable rework
- after rework the height of the frame should not be affected
- it should not be visible that rework has been carried out when the lid has been mounted

Refer to the pictures below of the primary and secondary sides for repairs that require the Shield Can Fence to be modified:

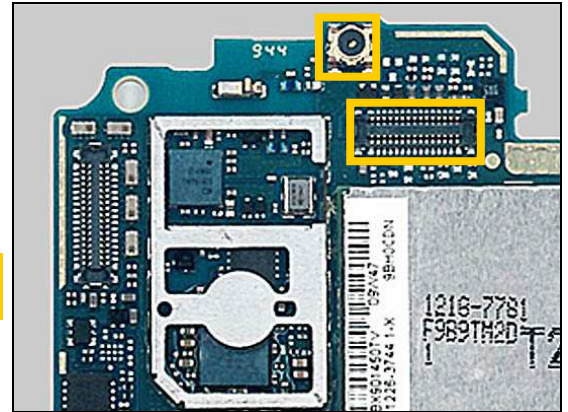
1

L3000,L3001,L3002,L3003,L3004,N3004,R3056,
V3011,X1401

Protect BtB connector and RF-probe connector with capton tape!

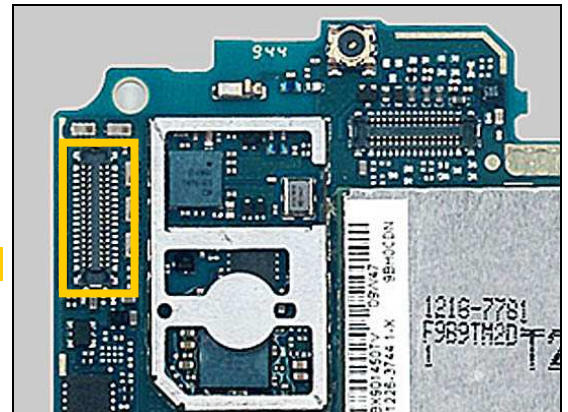
2

N4153,Z2500, Z2501, Z2502, Z2503, Z2504

Protect BtB connector with capton tape!

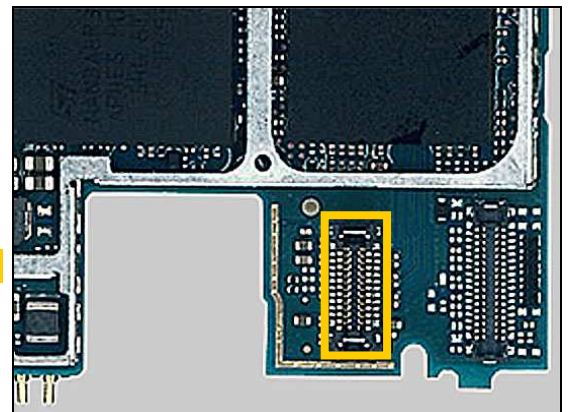
3

Z2800,Z2801,Z2802

Protect two BtB connectors with capton tape!

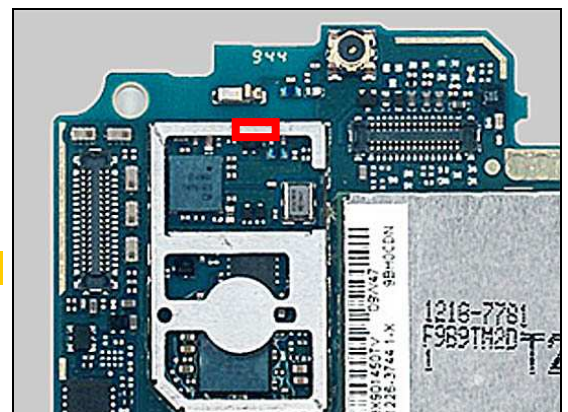
4

Z1500

Cut the shield fence as shown!
